# BELZONA GUIDES GATE VALVE REPAIR

ID: 1601

1400mm (55") NB Gate Valve

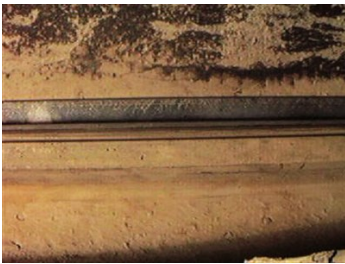
On both of the trapezoidal guides in the body there was severe metal loss caused during operation of the gate. The material loss was on average 6-8mm, occasionally 10mm (0.4"), over a length of 1600mm (63")

- \* Corrosion to the guides ,
- \* The completed application after forming ,
- \* Refitting the valve ,
- \* Finished repair ,

The application was carried out in accordance with Belzona Know-How System Leaflet VPF-4. The guides were grit blasted to remove the corrosion. Moisture was driven out of the cast iron, followed by a second grit blasting. Using forming methods the guides were rebuilt, and then deburred prior to reassembly.
