BELZONA GUIDES GATE VALVE REPAIR

1400mm (55") NB Gate Valve

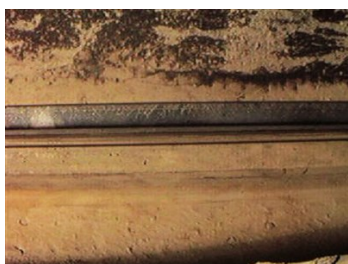
On both of the trapezoidal guides in the body there was severe metal loss caused during operation of the gate. The material loss was on average 6-8mm, occasionally 10mm (0.4"), over a length of 1600mm (63")

The application was carried out in accordance with Belzona Know-How System Leaflet VPF-4. The guides were grit blasted to remove the corrosion. Moisture was driven out of the cast iron, followed by a second grit blasting. Using forming methods the guides were rebuilt, and then deburred prior to reassembly.
