BELZONA RESTORES HYGEINE IN BOTTLING ROOM

Customer Location: Bottled Water Manufacturer, Perthshire, UK

Application: FPA-Floor Problem Areas

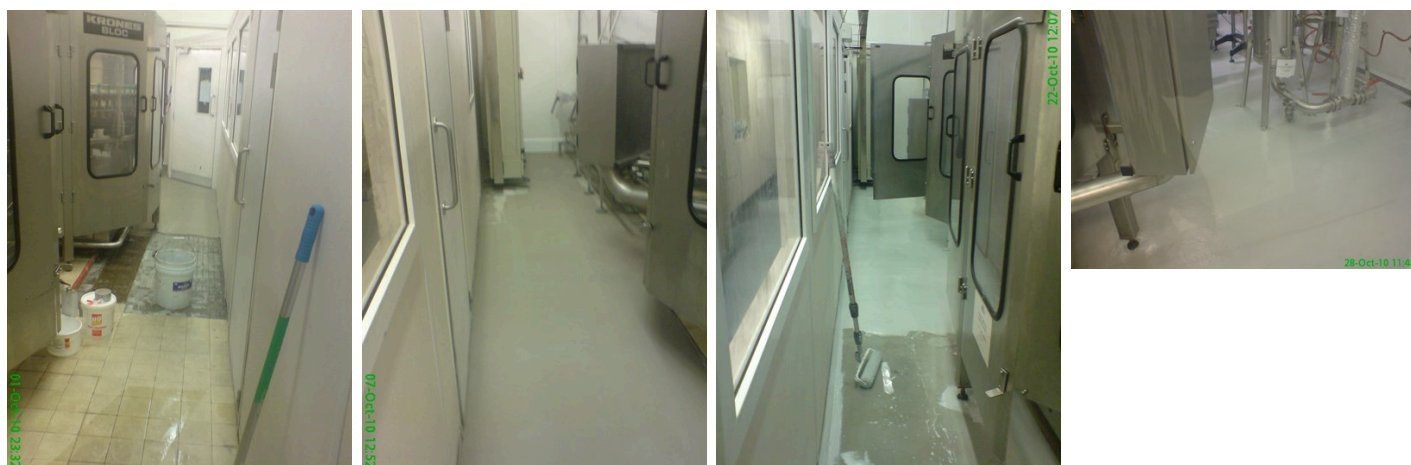
Photograph Descriptions

There were several cracked and broken tiles. This created a potential hygiene problem and required rectifying to remove traps for bacteria and to aid cleaning.

- * Damaged tiles being repaired with Belzona® 4131 ,
- * Floor levelled with Belzona® 4131 ,
- * Light grey Belzona® 5231 being applied ,
- * Completed floor coating ,

Application was carried out in accordance with Belzona Know-How System Leaflets FPA-1 & 3. Belzona® 4131 was used to replace loose tiles sand create a uniform surface prior to application of the Belzopna® 5231.
