# BELZONA RESTORES HYGEINE IN BOTTLING ROOM

ID: 1605

Customer Location: Bottled Water Manufacturer, Perthshire, UK

Application: FPA-Floor Problem Areas

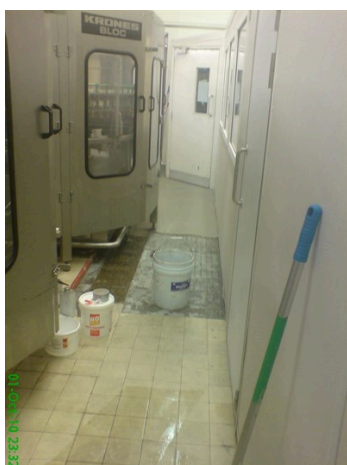
There were several cracked and broken tiles. This created a potential hygiene problem and required rectifying to remove traps for bacteria and to aid cleaning.

- \* Damaged tiles being repaired with Belzona® 4131 ,
- \* Floor levelled with Belzona® 4131 ,
- \* Light grey Belzona® 5231 being applied ,
- \* Completed floor coating ,

Application was carried out in accordance with Belzona Know-How System Leaflets FPA-1 & 3. Belzona® 4131 was used to replace loose tiles and create a uniform surface prior to application of the Belzona® 5231.

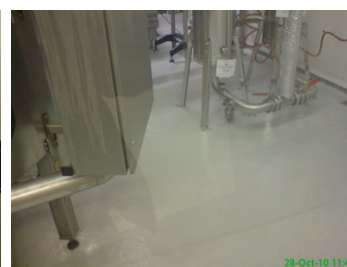
The Belzona System creates a level, seamless surface that is hygienic in this critical area. The low VOC, low odour of the system was a further benefit in this bottling plant.
