BELZONA REFURBISHMENT MAKES FIRE ESCAPE SAFE

ID: 1606

Customer Location: Police Station, UK
Application Date: November 2010

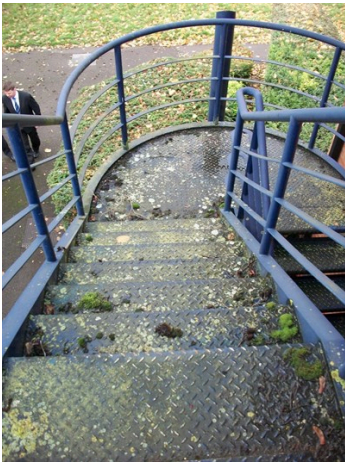
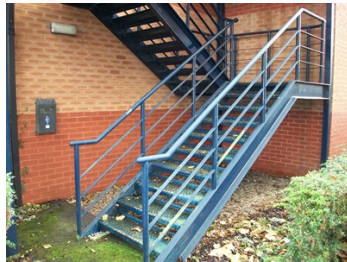
Regular foot traffic and weathering caused the steps of this fire escape to become damaged and worn and had made it a potential slip hazard.

- * Original condition of the entrance steps ,
- * Original condition of the entrance steps ,
- * The finished application ,
- * The finished application ,

Application was carried out in accordance with a modified Belzona Know-How System Leaflet FPA-8. Belzona® 4411 (Granogrip) was applied to the steps with aggregate incorporated in grey and yellow. Belzona® 5111/6111 system applied to the hand rails. Belzona® 1111 was used to smooth out corroded steelwork.
