BELZONA REFURBISHMENT MAKES FIRE ESCAPE SAFE

ID: 1606

Customer Location: Police Station, UK

Application Date: November 2010

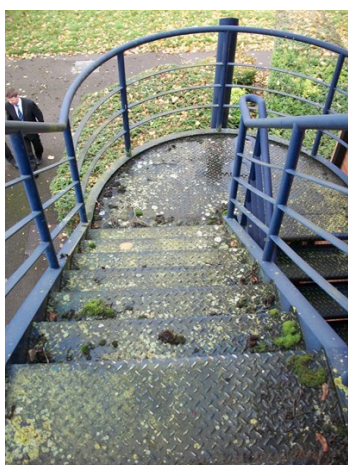
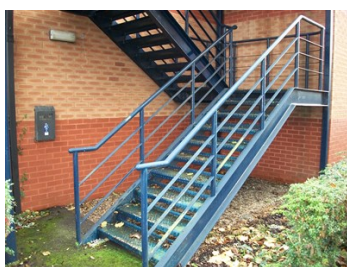
Regular foot traffic and weathering caused the steps of this fire escape to become damaged and worn and had made it a potential slip hazard.

- * Original condition of the entrance steps ,
- * Original condition of the entrance steps ,
- * The finished application ,
- * The finished application ,

Application was carried out in accordance with a modified Belzona Know-How System Leaflet FPA-8. Belzona® 4411 (Granogrip) was applied to the steps with aggregate incorporated in grey and yellow. Belzona® 5111/6111 system applied to the hand rails. Belzona® 1111 was used to smooth out corroded steelwork.
