BELZONA REFURBISHMENT OF FAN HUB SAVES TIME AND MONEY

Customer Location: Power Plant, Turkey
Application Date: December 2010

Cooling Tower Fan Blade case, diameter 1854mm, width 537mm

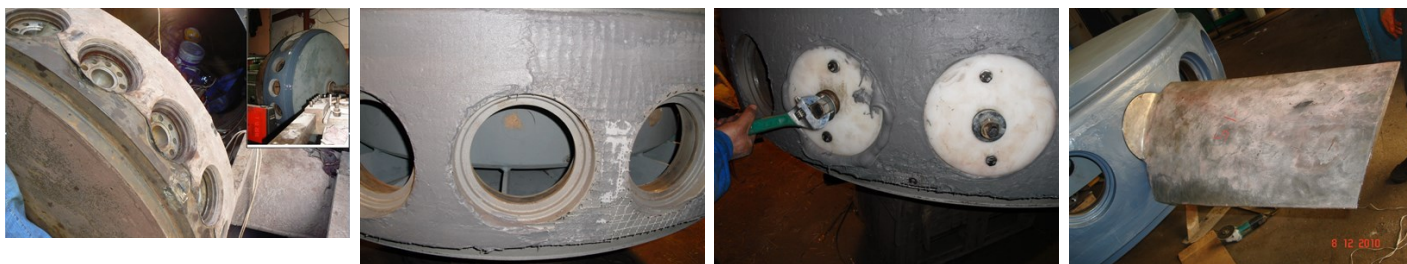
Photograph Descriptions

Erosion/Corrosion following failure of previous coating. If allowed to continue could cause severe damage to the fan.

- * Badly corroded case especially bottom side of fan blades ,
- * Wire mesh and formers cut by CNC used to achieve correct profiles ,
- * Application of Belzona® 1111 to case with templates in place to form fan pockets ,
- * Finished application. Rebuild and protective coating applied. Checking each hole by installing fan blade ,

application was carried out in accordance with Belzona Know-How System Leaflets FBC-4 & FBC-2.

Formers were used to achieve correct profile for blade sockets.

Belzona restored the eroded surfaces. Alternative method by welding might cause distortion and its machining process is laborious and expensive, besides thermal stress could have a negative effect on balance as fan operates at 750rpm. Belzona solution is corrosion resistant, straight forward, time and cost effective. It saved time and avoided start-up delay.
