# BELZONA REPLACES FAILED TANK BASE SEAL

**Industry:** Chemical & Petrochemical  
**Application:** TCC-Tanks and Chemical Containment Areas  
**Substrate:** Steel & concrete  
**Products:** \* Belzona® 4131 (Magma-Screed),  
\* Belzona® 3111 (Flexible Membrane System),

**Customer Location:** Chemical plant, UK  
**Application Date:** November 2004

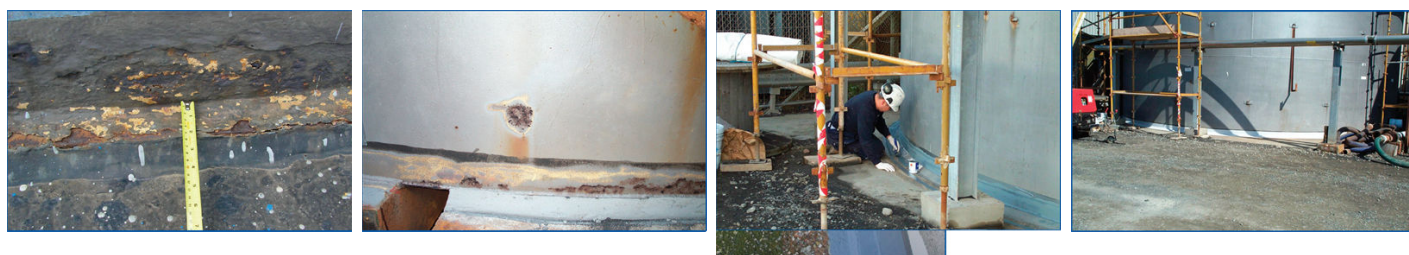
## Photograph Descriptions

Original seal had cracked and allowed moisture to penetrate beneath tank base. Problem exacerbated by poor water shed leading to external corrosion.

- \* Close up showing failure of original seal. ,
- \* Fillet of Belzona® 4131 applied ,
- \* Application of Belzona 3111® System underway. ,
- \* Application completed. ,

Traditional sealing materials had failed due to lack of flexibility. Improved water shed created by applying fillet of Belzona® 4131. Belzona® 3111 has a proven track record in waterproofing tank bases.
