# BELZONA FIRST CHOICE FOR TANK BASE SEALING

Customer Location: Bulk Chemicals Manufacturer, UK  
Application Date: August 2005

An 8.5m Acrylonitrile storage tank was identified to need a more effective base seal to prevent under floor corrosion.

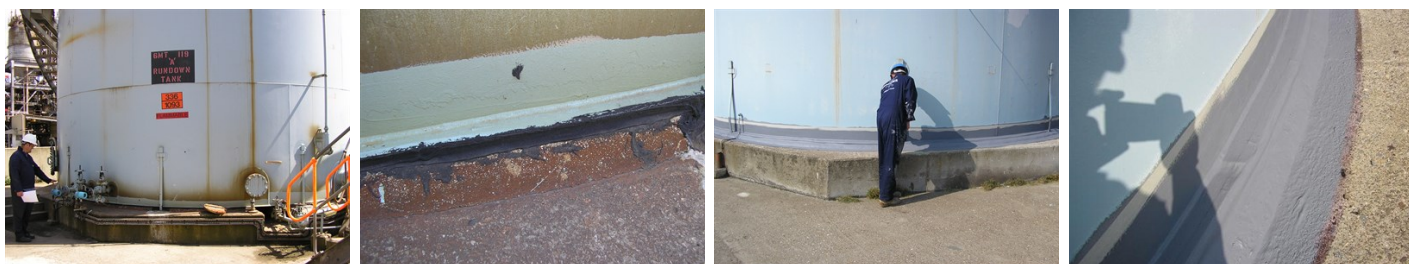
External corrosion of the tank base due to failure of the original seal.

- \* General view of tank ,
- \* Previous sealing system ,
- \* Application in progress ,
- \* Finished application with just the masking tape to remove ,

Application was carried out in accordance with Belzona® Know-How System Leaflets GSS-3.
