# BELZONA® 2211 SAVES EXPANSION JOINTS AT NEW AIRPORT

**Customer Location:** New Metropolitan Airport  
**Application Date:** October 1995

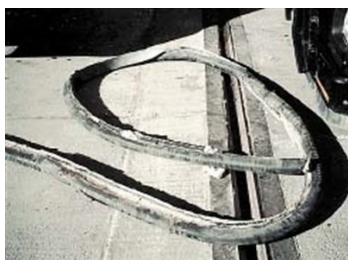
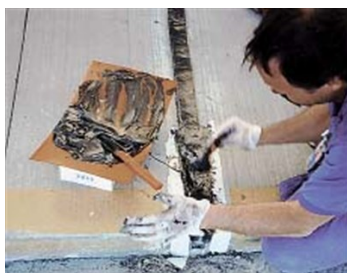
Outdoor expansion joints created hazards for people and equipment at the main loading and unloading gates.

\* Backer rod with previous failed product pulled from joint, notice substrate chunks attached to failed product Close to the end of filling the joint The cured section, ready for service ,

The application was carried out in accordance with Belzona Know-How Leaflets FPA-5 and FPA-6.

Only Belzona® 2211 had the proper combination of hardness, elasticity, adhesive strength, and paste grade application control. A long shelf life allows the customer to purchase larger quantities with confidence and lets them continue repairs with products from stock as time permits.
