# BELZONA EXTENDS LIFE OF PULP BLENDER

Industry: *Pulp & Paper*

Customer Location: *Paper mill, Spain*

Outlet pipe of an industrial blender

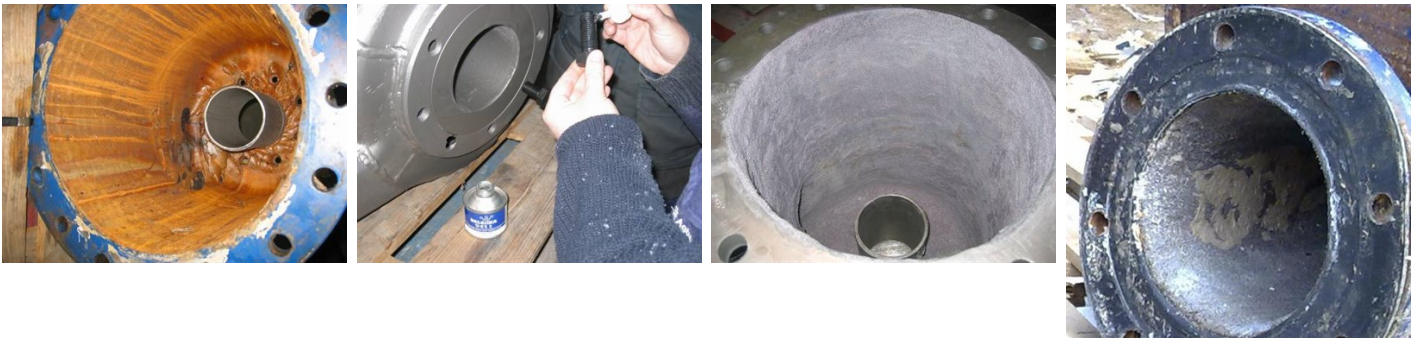
## Photograph Descriptions

*Pump and bolt threads were severely damaged by the highly abrasive stream of shredded paper pulp flowing through it*

- \* Pipe before application ,
- \* Applying Release Agent to the bolts ,
- \* Completed application ,
- \* View of the pipe after 3 &frac12; years service ,

Application was carried out in accordance with Belzona Know-How System Leaflets ENC-2 & SHM-11. The casing threads were reformed with Belzona® 1111 using the bolts treated with Belzona Release Agent as formers. The internals of the pipe were lined with Belzona® 1812.

Prior to contacting Belzona, the company had to replace this piece of equipment every 1 or 2 years. An inspection of the Belzona

lining 3 ½ years later, in August 2010 showed it was still in place and none of the metal parts were exposed. As a result, the customer asked Belzona for several similar applications.
