BELZONA PROVIDES COST EFFECTIVE SOLUTION TO CONVEYOR BELT REPAIRS

ID: 1621

Application: SHM-Solids Handling Machinery

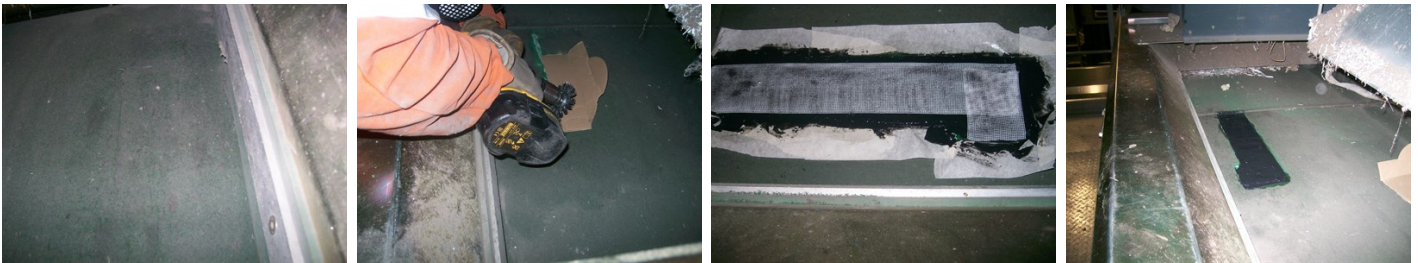
Photograph Descriptions

An L shaped cut approximately 300mm across the length of the belt was found in a new conveyor belt.

- * Damaged conveyor belt - L shaped cut ,
- * Surface being prepared using a wire brush on a hand drill ,
- * Belzona Conditioner applied with 1 coat of product and reinforcing tape laid on top ,
- * Completed conveyor repair ,

The application was carried out in accordance with Belzona Know-How system Leaflet SHM-1. Top cover was cut back before repairing with Belzona® 2311 incorporating Belzona® 9341 (Reinforcement Tape).
