# BELZONA REPAIRS LEAKING HEAT EXCHANGER TUBE SHEETS

**Industry:** Marine  
**Application:** HEX-Heat Exchangers  
**Substrate:** Steel & Copper  
**Products:** \* Belzona® 1311 (Ceramic R-Metal) ,  
\* Belzona® 1321 (Ceramic S-Metal) ,

**Customer Location:** Maritime repair agent, Bulgaria  
**Application Date:** December, 2010

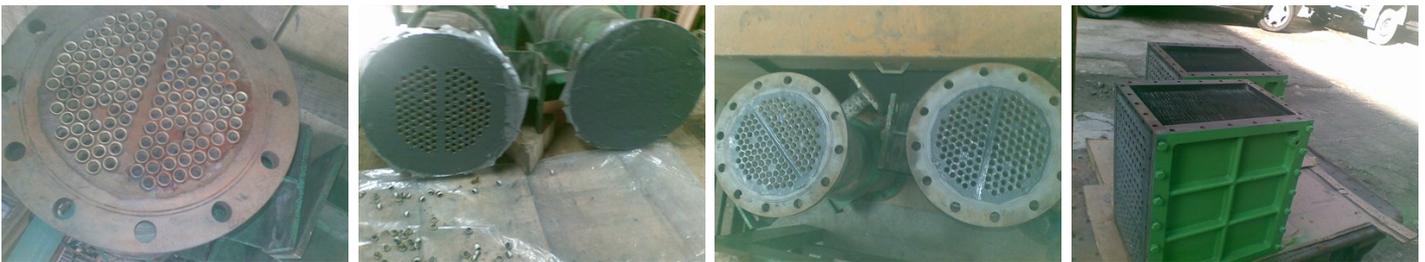
## Photograph Descriptions

Severe erosion and galvanic corrosion between copper tubes and steel tube sheet.

- \* The severe damage clearly evident ,
- \* After grit blasting, the eroded tube sheet was rebuilt with Belzona® 1311 ,
- \* The coolers after application of Belzona® 1321 ,
- \* Further air coolers were also repaired ,

Applications were carried out in accordance with Belzona Know-How System Leaflets HEX-1 and HEX-3.

Customer chose the Belzona method because alternatives were either expensive replacement of the equipment or time consuming machining repair to replace the tube sheets. The repair with Belzona was completed in three days and almost ten times lower in cost than replacement.
