BELZONA REPAIRS LEAKING HEAT EXCHANGER TUBE SHEETS

ID: 1622

Customer Location: Maritime repair agent, Bulgaria
Application Date: December, 2010

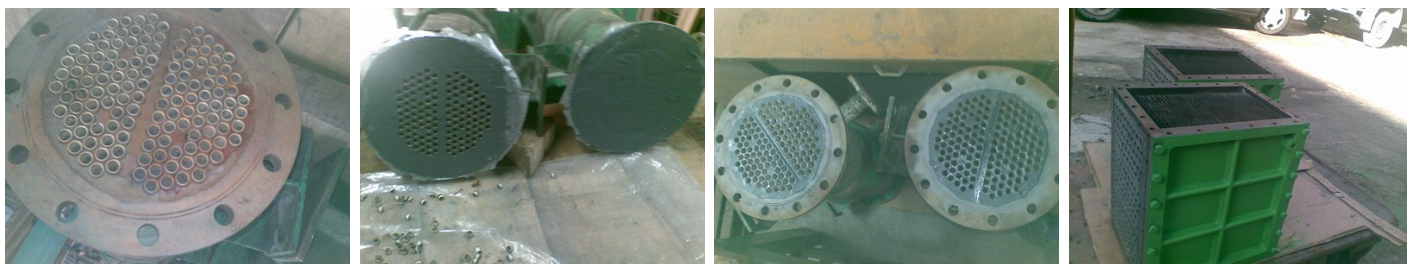
Photograph Descriptions

Severe erosion and galvanic corrosion between copper tubes and steel tube sheet.

- * The severe damage clearly evident ,
- * After grit blasting, the eroded tube sheet was rebuilt with Belzona® 1311 ,
- * The coolers after application of Belzona® 1321 ,
- * Further air coolers were also repaired ,

Applications were carried out in accordance with Belzona Know-How System Leaflets HEX-1 and HEX-3.

Customer chose the Belzona method because alternatives were either expensive replacement of the equipment or time consuming machining repair to replace the tube sheets. The repair with Belzona was completed in three days and almost ten times lower in cost than replacement.
