# WORLD'S LARGEST PHOSPHORIC ACID PLANT USES COST EFFECTIVE BELZONA SOLUTION

Customer Location: Phosphoric acid plant, Orissa, India  
Application Date: December 2010

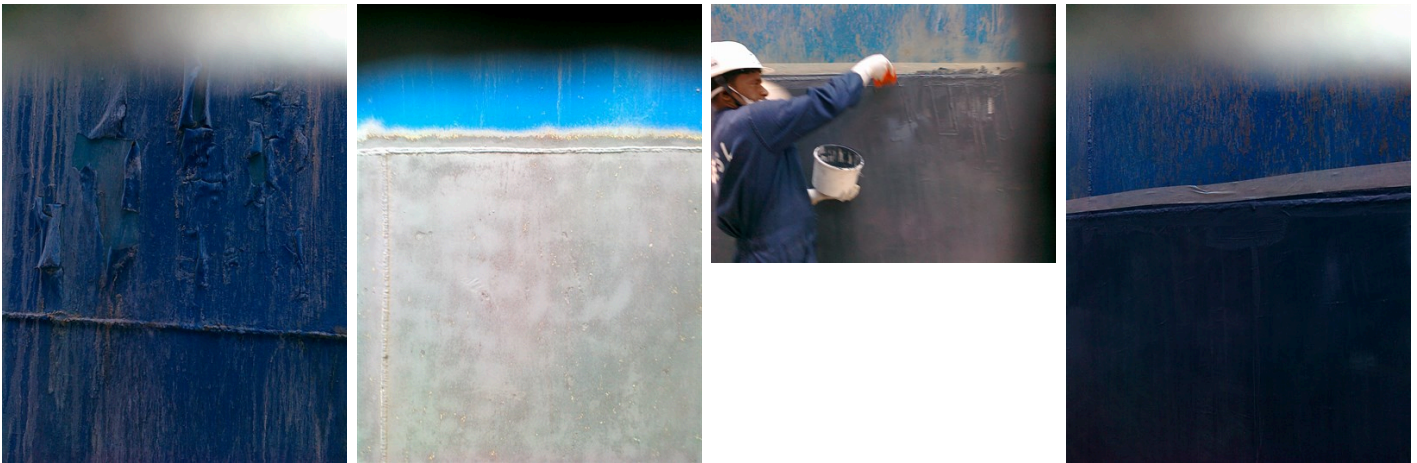
Standard Epoxy paints were peeling off within 6-8 months and outside of storage tanks get heavily corroded, mainly on the bottom portion at a height of 2 metres from the foundations.

- \* Deterioration of existing coating on Phosphoric acid storage tank clearly evident ,
- \* Surface preparation done by grit blasting ,
- \* Application of Belzona® 4311 ,
- \* Finished application ,

Storage Tank - Capacity - 2650 T / Day was suffering huge chemical and environmental corrosion due to fumes of Phosphoric and Sulphuric acid and coastal environment.

Application was carried out in accordance with Belzona Know-How System Leaflet TCC-5. Since rebuilding was not required

Belzona® 4311 has been applied directly on the blasted surface after cleaning.
