# BELZONA PUMP DIFFUSER PROTECTED

ID: 163

Customer Location: *Sewage Treatment Plant in Northern California*

Application: *CEP-Centrifugal Pumps*

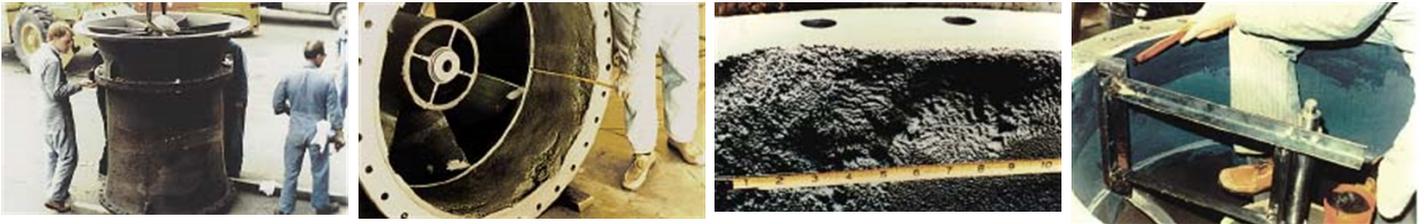
## Photograph Descriptions

*Erosion/corrosion and cavitation*

- \* The diffuser removed for repairs ,
- \* Damage on flow surface ,
- \* Close up of cavitation pitting ,
- \* Repairs in progress using a rotating jig to create the internal shape and dimension without machining ,

Centrifugal pump diffuser

The application was carried out in accordance with Belzona Know-How Leaflets CEP-1 and CEP-2.

This pump was in service for seven years with no damage until the unit was removed from service for other reasons. Extending the life of the pump diffuser saved the plant tremendous replacement costs.
