# BELZONA PROTECTS WET CYLINDER LINERS ON DIESEL ENGINE

ID: 1633

Customer Location: Small Power Utilities Group, Philippines  
Application Date: August, 2010

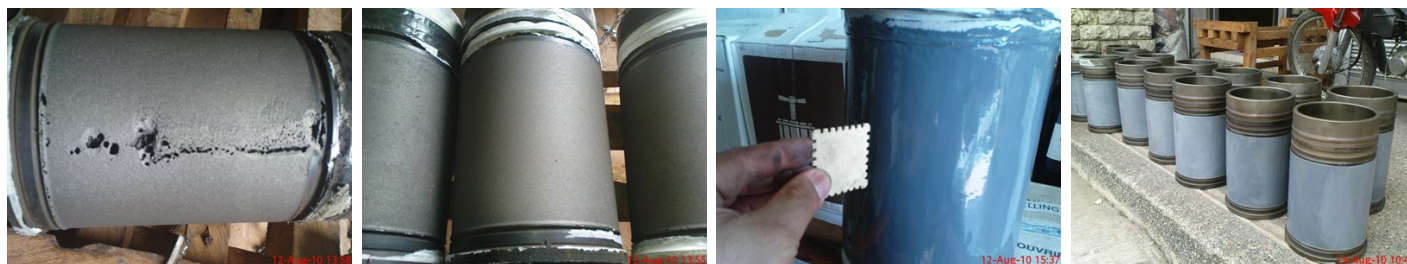
Erosion corrosion pitting on liner bodies.

- \* Pitting on the body of the wet cylinder liners ,
- \* Cylinder liner after grit blasting ,
- \* Checking the application thickness ,
- \* Some of the 24 units repaired and protected with Belzona ,

The application was carried out in accordance with Belzona System Leaflet ENC-6. Pitting was filled with Belzona® 1311 before providing overall erosion corrosion protection with Belzona® 1391 coating.
