BELZONA SEALS PLANT ROOM FLOOR

ID: 1637

Customer Location: *Hospital, UK*
Application Date: *May 2009*

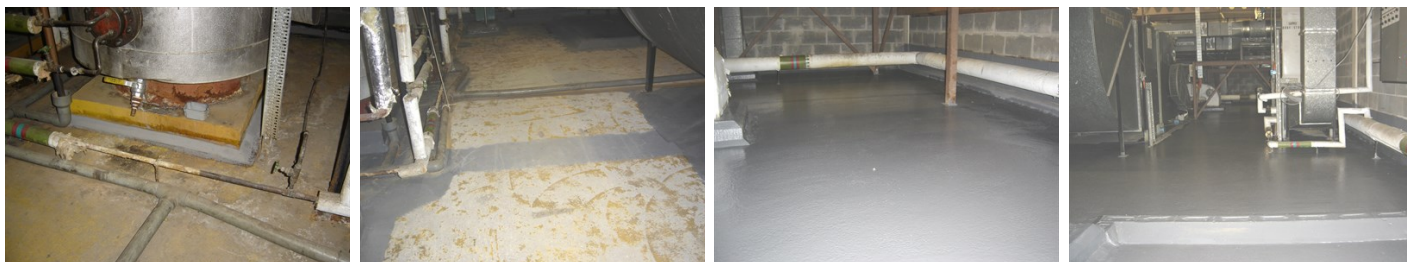
Water was leaking through the floor to the operating theatres below.

* Damaged floor Belzona® 5231 application starting Completed application Completed application ,

Application was carried out in accordance with Belzona Know How System Leaflet FPA-8. The floor was first diamond ground and then two coats of Belzona® 5231 (SG Laminate) applied.
