BELZONA KEEPS MANUFACTURER COOL

Customer Location: Aluminium Casting Manufacturer, N. Ireland

Application: CEP-Centrifugal Pumps

Cooling tower at this major manufacturer of Aluminium castings for the motor industry

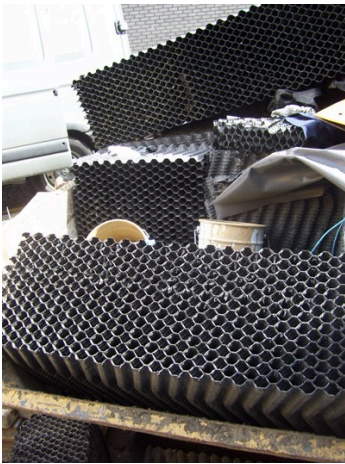
- * Packing removed ,
- * Tented up and ready for application ,
- * Completed application ,
- * Floor area completely protected with Belzona[®] 5811 ,

Application was carried out in accordance with Belzona Know-How System Leaflets TCC-1 & TCC-5. After removing roof and removing all the packing (used to increase surface area), Belzona[®] 1111 was used to bond doubler plates over holed/thinned areas before the entire surface was protected with Belzona[®] 5811.
