BELZONA HELPS KEEP THE FARMS FREE FROM FLOODING

Customer Location: Water Authority, UK

Application: CEP-Centrifugal Pumps

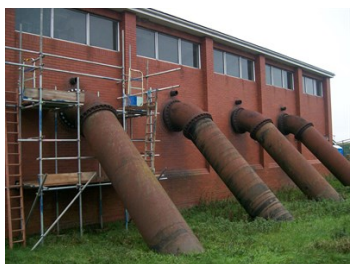
- * General view of the pumping station with the 4 outlet pipes ,
- * The damaged pipe ,
- * Belzona[®] 1291 applied to stem leak ,
- * Pipe completely wrapped with Belzona 1161 ,

Pumping station used to regulate the water table in the surrounding low lying farmland. There are 4 pump sets that transfer water from the land into the nearby river to prevent flooding.
