BELZONA OVERCOMES PROBLEM OF LEAD THEFT

ID: 1643

Customer Location: *Local School, UK*
Application Date: *2008*

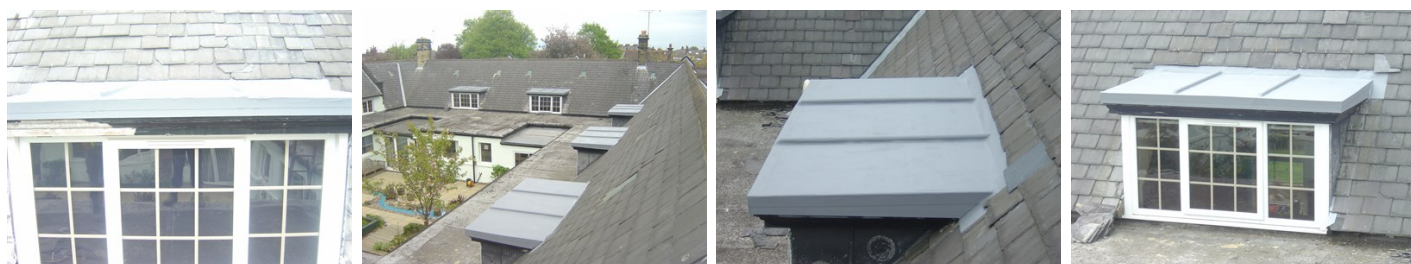
Photograph Descriptions

This school had recently suffered from theft of the lead from their roof. The damage was so extensive that if not addressed, it would lead to structural defects resulting in a potentially disruptive high cost maintenance repair.

- * Window before application ,
- * General view of the roof ,
- * Application completed ,
- * Application completed ,

Application was carried out in accordance with Belzona Know-How System Leaflet RPA-2. Roof was felted prior to sealing with fully reinforced Belzona® 3111 system.

The repairs were completed in less than one week. Revisiting the application in 2010, the school has not experienced any further problems, and the repair is still in excellent condition.
