BELZONA SEALS ROOFTOP EXPANSION JOINTS

Industry: *Buildings & Structures*
Application: *RPA-Roof Problem Areas*
Substrate: *Concrete*
Products: ** Belzona® 4111 (Magma Quartz) ,*
** Belzona® 3121 (MR 7) ,*

Customer Location: *University, Leeds, UK*
Application Date: *December 2010*

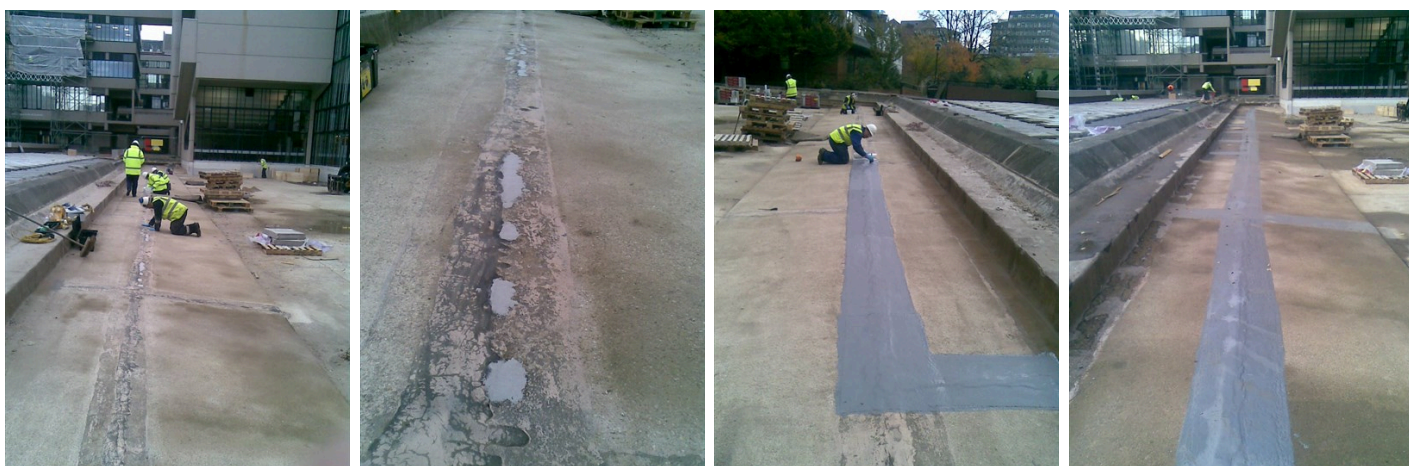
Pond had been drained for refurbishment and concern was expressed over the waterproofing of the expansion joints.

- * Roof showing signs of damage ,
- * Close up of the damage ,
- * Application in progress ,
- * The application completed ,

Application was carried out in accordance with Belzona Know-How System Leaflets FPA-1 & RPA-1. After cleaning and drying, all loose concrete was removed and repaired using Belzona® 4111 followed by two coats of reinforced Belzona® 3121 to bridge the joints.
