# BELZONA CHILLS OUT BREWERY

**Industry:** Heating, Ventilation & Air Conditioning  
**Application:** HEX-Heat Exchangers  
**Substrate:** Copper tubes, steel tube sheet  
**Products:** \* Belzona® 1311 (Ceramic R-Metal) ,  
\* Belzona® 1321 (Ceramic S-Metal) ,

**Customer Location:** A Mid-Western Brewery in Missouri  
**Application Date:** December 1995

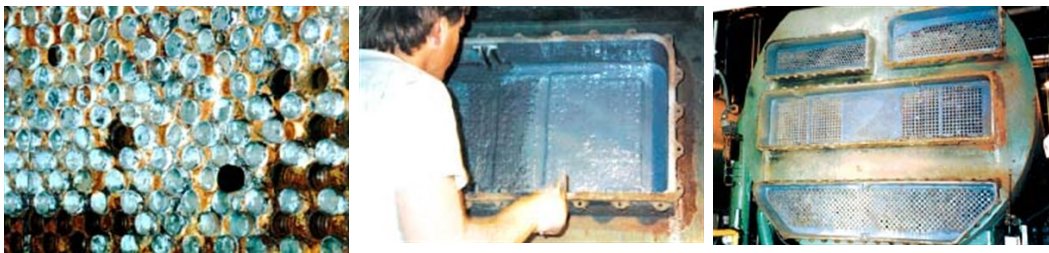
*The tube sheet was badly eroded/corroded. There were numerous leaks between the tubes and the tube sheet.*

- \* Close up view of one of the eroded/corroded areas ,
- \* Application of Belzona® 1321 over Belzona® 1311 ,
- \* Completed job, tube sheet rebuilt ,

The application was carried out in accordance with Belzona Know-How Leaflet HEX-1.

The area coated was 60 sq. ft. on each end. Two more units are scheduled this year. The customer benefited by saving replacement costs, reduced down time and continuation of the manufacturing process.
