# BELZONA REPAIRS COLOUR MATCH SPALLED LINTELS

ID: 1681

**Customer Location:** Local Education Authority, UK  
**Application Date:** September 2009

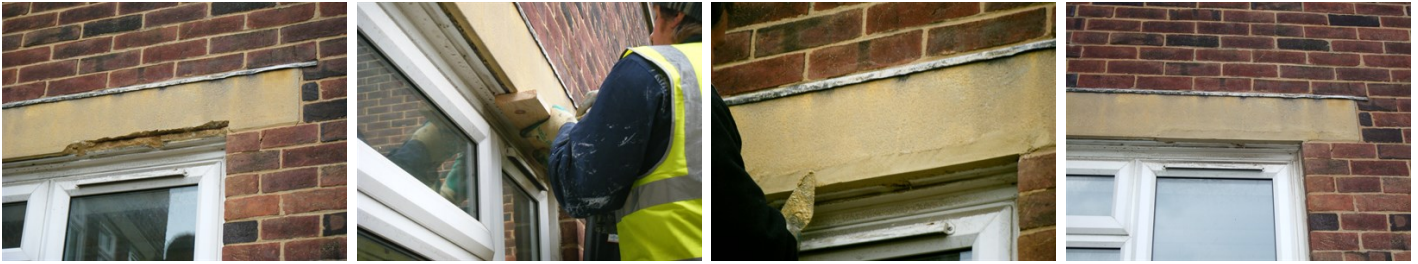
Spalled concrete due to rebar corrosion.

- \* Spalled concrete. ,
- \* Application in process using straight edge to form neat corner. ,
- \* Completing the application. ,
- \* Completed application. Note excellent colour match. ,

Concrete lintels.

Application carried out in accordance with Belzona Know-How System Leaflet WPA-4. Belzona® 4141 was colour matched to existing concrete using Iron Oxide pigments.

Repair was carried out quickly without need for scaffolding or permanent shuttering. Ability to colour match the repair ensured aesthetic acceptability.
