BELZONA REFURBISHES THE FLOORS

ID: 169

Customer Location: Airport Food Service in Missouri
Application Date: February 1996

Wash area floor for aircraft food service carts

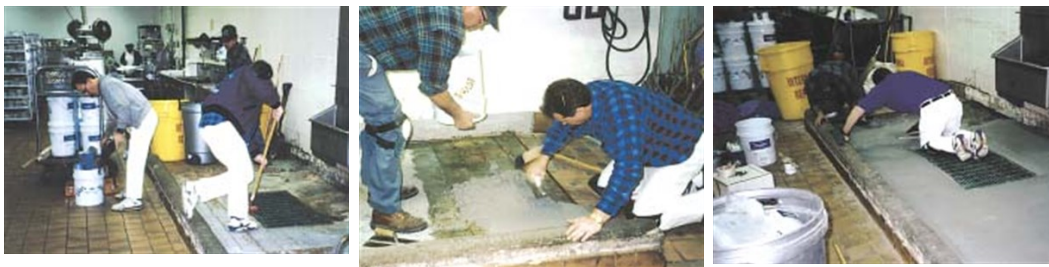
Photograph Descriptions

Water was trapped under the tile, causing the tile to break up and providing a haven for bacteria and mold. Pushing the carts over rough, broken, and missing tile posed a serious safety hazard as well.

- * Removing old tile, dirt and concrete ,
- * Beginning application of Belzona® 4131 (Magma Screed) ,
- * Job almost completed ,

Old concrete was removed and 1 1/2" voids were left in several areas. Belzona® 4131 (Magma Screed) was applied over the areas where the minimum depth was 3/8". The application was carried out in accordance with Belzona Know-How Leaflet FPA-1.

The application covered a 72 square foot area and took only two hours to complete. The wash area is now a safer and cleaner place to work.
