Belzona refurbishes schools floor

ID: 1696

Industry: Buildings & Structures
Application: FPA-Floor Problem Areas
Substrate: Concrete with an existing coating unknown
Products: * Belzona® 5231 SG Laminate ,

Customer Location: Cheltenham, UK
Application Date: October 2010

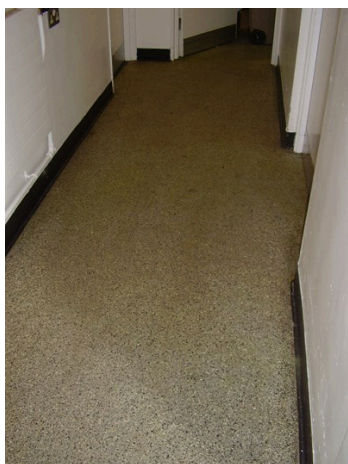
They had a few slips on the existing floor and requires a quick curing application which could be carried out within four days start to finish with no solvent smells.

* Corridor prior to the application Kitchen prior to the application Corridor after application Kitchen after application ,

Application was carried out in accordance with Belzona Know-How System Leaflet FPA-1. The application was carried out in three steps, mechanical abrasion, clean/degrease and then, two coats of Belzona® 5231.
