# BELZONA CAT BLOCK

**Customer Location:** Heavy equipment engine supplier in Missouri, USA

**Application:** ENC-Engines and Casings

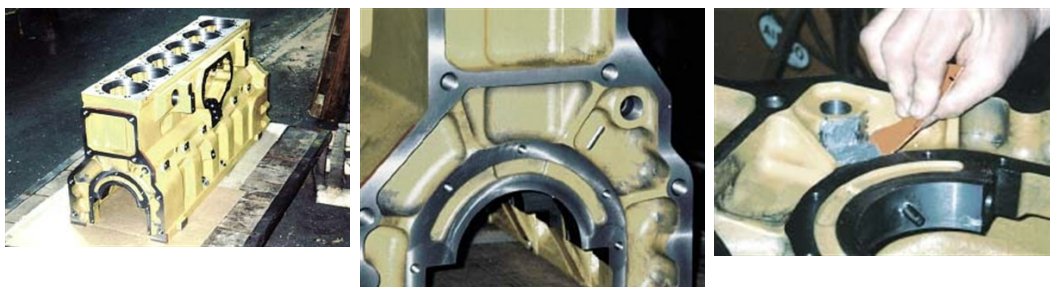
Due to a design flaw in the casting, a drilled oil passageway broke through the side of the engine block.

- \* View of the engine block. ,
- \* Close-up of broken out oil passageway. ,
- \* Dowel pin coated with Belzona® 9411 (Release Agent) in place, Belzona® 1111 (Super Metal) being applied. ,

The application was carried out in accordance with a modified version of Belzona Know-How Leaflet ENC-1.
