# CHIMNEY SHINES WITH BELZONA PROTECTION

ID: 1717

Customer Location: Powerstation, Poland  
 Application Date: September, 2008

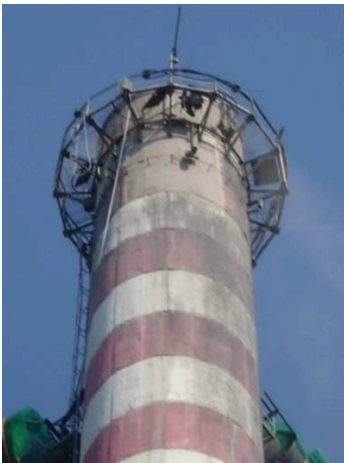
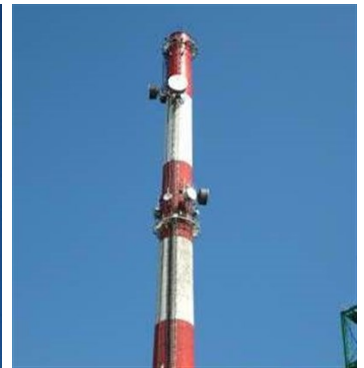
The existing coating systems had reached the end of their life and broken down resulting in an unattractive and poorly protected chimney stack. The client undertook a comparison of Belzona with a competitor.

- \* September 2008 pre works ,
- \* Application underway via rope access ,
- \* Completed application ,
- \* The top two, shiny bands are Belzona® 5111 ,
- \* Review in 2010 - note the top two bands are still shiny ,

Application was carried out in accordance with a modified Belzona Know-How System Leaflet WPA-2. Rope Access Technicians were used in place of industrial scaffolding. The top two, most aggressively attacked bands were coated using Belzona® 5111 in red and white.

After initial review it was noted that the Belzona® 5111 quite literally outshone the competition. Aside from the chemical and UV resistance needed for the application, the smooth surface of Belzona® 5111 did not attract dirt and would "self clean" with rain.
