# BELZONA BONDS PIPE SUPPORTS TO TANK

**Industry:** Chemical & Petrochemical  
**Application:** VPF-Valves, Pipes and Fittings  
**Substrate:** Carbon Steel  
**Products:** \* Belzona® 1121 (Super XL Metal) ,

**Customer Location:** Tank Farm, Dublin, Ireland  
**Application Date:** December 2002

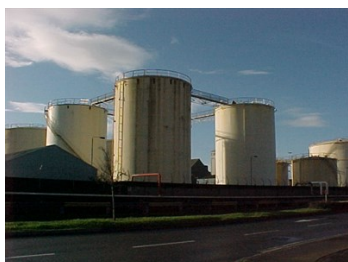
- \* Tank Farm Location ,
- \* Tank Farm Location ,
- \* Close up showing the bracket bonded. The rust was due to the later coating of the tank/bracket ,
- \* Additional view of bonded brackets ,
