# BELZONA® REPAIRS A FRANCIS TURBINE

ID: 1736

Customer Location: Hydroelectric power plant / Moulin Neuf, France

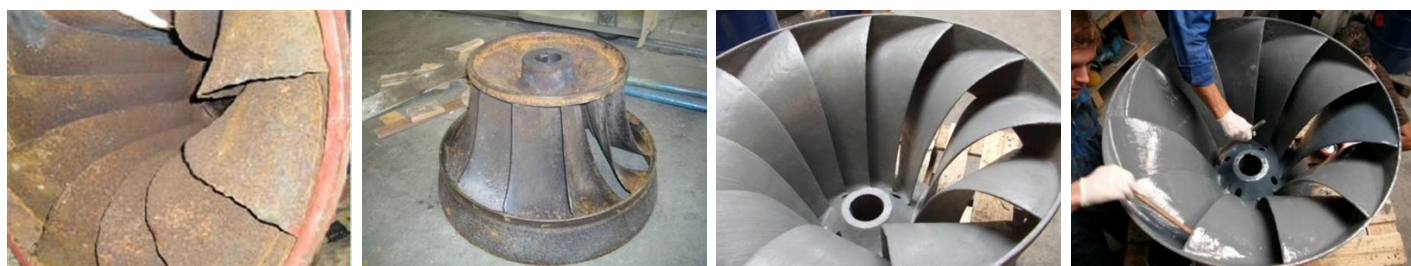
## Photograph Descriptions

\* Original turbine After disassembling After rebuilding with Belzona® 1311 Application of 2 coats of Belzona® 1321 ,

This turbine was in operation since 1976 and showed significant erosion-corrosion.

Application was carried out in accordance with Belzona Know-How System Leaflets CEP-3 & 5. Belzona® 1311 was used to restore profiles before overcoating with Belzona® 1321 to provide protection from further erosion-corrosion.

The Belzona solution has avoided the replacement of the turbine which would have cost between 30000€ and 50000€. About 50 hours of works were needed to repair this turbine and the repair cost 10000€ to the client.
