BELZONA CONCRETE COOLING TOWER BASINS

ID: 177

Application: HEX-Heat Exchangers

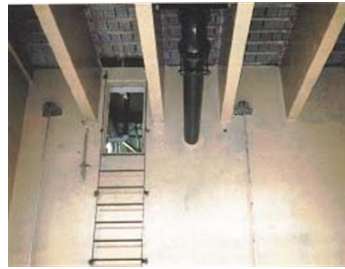
Basins were deteriorated due to attack from chemically treated water. Left unchecked the concrete would continue to degrade and eventually result in leakage.

- * Outside view of the tower, drainage and clean-up begins. ,
- * Coating inside the basin commences. ,
- * The completed job, concrete sealed and protected. ,

Cooling tower basins required protection

Application was carried out in accordance with Belzona Know-How Leaflet HEX-7.

Approximately \$30,000 in Belzona materials were used to seal the porous surface and to avert costly leakage which could have resulted in inadequate cooling of the facility and contamination of the environment.
