# BELZONA CONCRETE COOLING TOWER BASINS

ID: 177

**Application:** HEX-Heat Exchangers

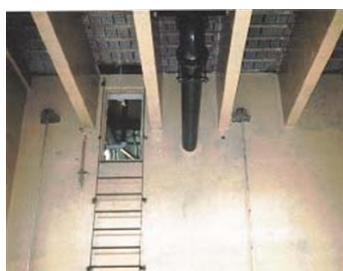
*Basins were deteriorated due to attack from chemically treated water. Left unchecked the concrete would continue to degrade and eventually result in leakage.*

- \* Outside view of the tower, drainage and clean-up begins. ,
- \* Coating inside the basin commences. ,
- \* The completed job, concrete sealed and protected. ,

Application was carried out in accordance with Belzona Know-How Leaflet HEX-7.
