BELZONA REFURBISHMENT OF AFTERCOOLER HEADS

ID: 179

Application: HEX-Heat Exchangers

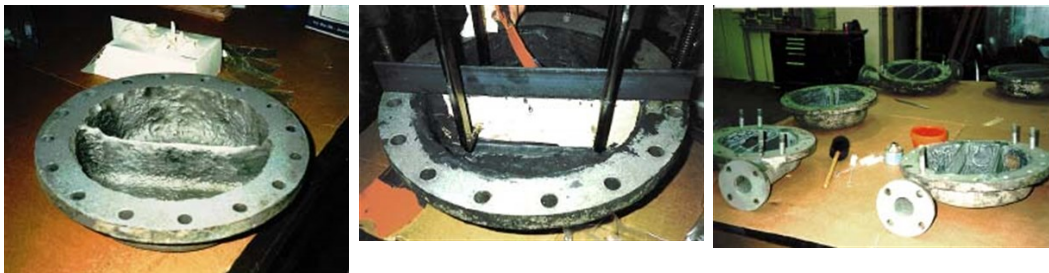
Photograph Descriptions

Years of erosion/corrosion had deteriorated the divider bars causing bypass and inefficiency.

- * Grit blasted cover. ,
- * Formers in place and coated with Belzona® 9411. Rebuilding with Belzona® 1311 in progress. ,
- * Rebuilding complete, all parts to be finish coated with Belzona® 1321. ,

All parts were rebuilt with Belzona® 1311 and resurfaced with Belzona® 1321. The cost was \$1,600. All parts are still in use today with no further damage.
