# BELZONA® 1591 PROTECTS OIL/GAS SEPARATORS AT HIGH TEMPERATURE

Industry: Oil & Gas  
Application: TCC-Tanks and Chemical Containment Areas  
Substrate: Steel  
Products: \* Belzona® 1591 ,

Customer Location: Oil separation equipment manufacturer  
Application Date: April 1997

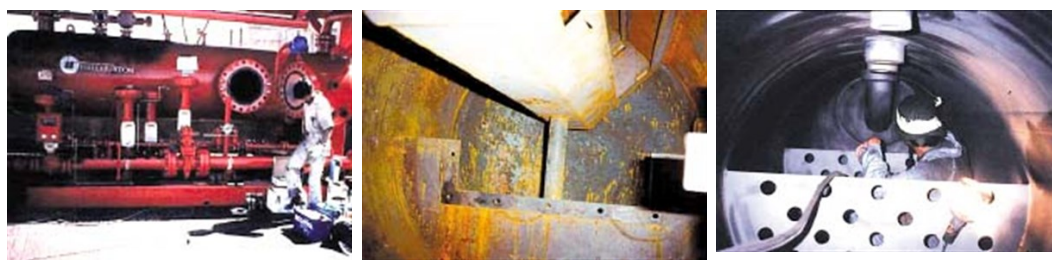
Severe erosion/corrosion to internal surfaces.

- \* General view of separator. ,
- \* Work underway applying Belzona® 1591. ,
- \* Final inspection being carried out. ,

Application was carried out in accordance with Belzona Know-How Leaflet TCC-3.

Regular refurbishment was necessary as previous coatings had failed due to high temperatures and explosive decompression. Belzona® 1591 specified to enable longer service life in extreme well conditions.
