# BELZONA DOES FLOORS

**Application:** TCC-Tanks and Chemical Containment Areas

Extreme erosion surrounding drains due to acidic water discharge

Chemical containment floor drainage area

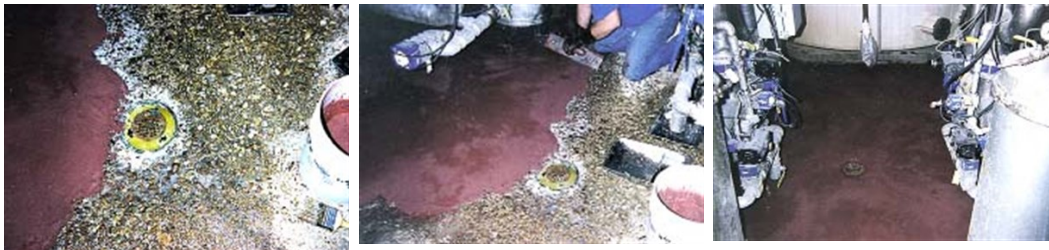
- \* Application commences, note the erosion of the concrete drain area. ,
- \* Application proceeds. ,
- \* Finished application, concrete protected and proper drainage restored. ,

Application was carried out in accordance with Belzona Know-How Leaflet TCC-9.

Concrete would not hold up to the conditions. To remove the tanks and install a new floor would cost \$60,000 and require 2-3 weeks downtime. Preparation took 8 hours and the application of product took 8 hours. The customer saved \$50,000 by using Belzona.
