# BELZONA DAM LOCK SEALED

ID: 188

**Customer Location:** Dam in Florida, U.S.A.  
**Application Date:** November 1998

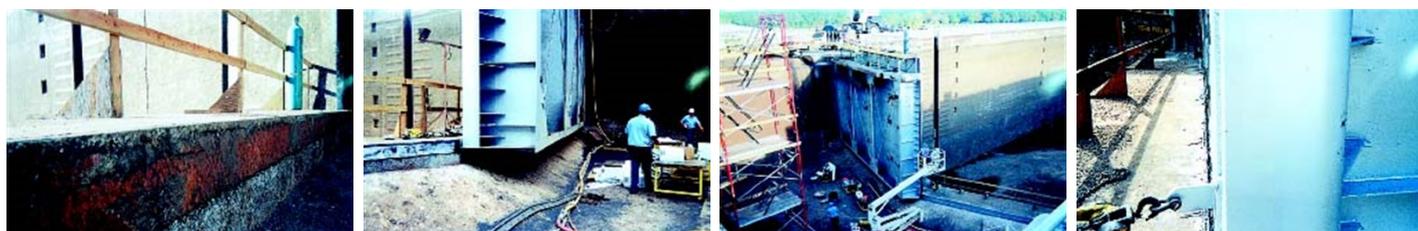
Lower seal on locks were leaking due to irregular metal-on-metal seal caused by cavitation.

- \* The culprit ,
- \* Surface preparation complete ,
- \* Work in progress ,
- \* The lock is sealed ,

Tremendous coordination was necessary between the contractor and the Army Corp of Engineers. Each door of the lock is 47 feet wide. Following surface preparation by grit blasting, product was applied to one side, TurtleWax® used as release agent to entire length of door seal.
