# BELZONA REPAIRS AN AUGER SCREW

Industry: Chemical & Petrochemical  
Application: SHM-Solids Handling Machinery

Customer Location: Chemical fertilizer producer, Tunisia  
Application Date: February 2005

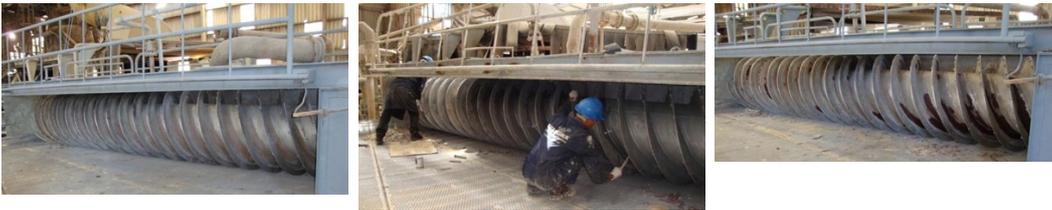
The weld area between the flights and auger shaft had been severely eroded due to the abrasive and corrosive nature of the phosphate. This erosion damage was around 20cm wide and spread over the length of the equipment.

- \* Grit-blasted auger screw ,
- \* Application of Belzona® 1811 ,
- \* Finished application ,

The application was carried out in accordance with Belzona Know-How System Leaflet SHM-14. The equipment was grit-blasted, degreased, then the eroded areas covered with 40kg of Belzona® 1811.
