# BELZONA® 1591 PROTECTING COALESCER VESSEL

ID: 19

Industry: Oil & Gas  
Application: TCC-Tanks and Chemical Containment Areas  
Substrate: Carbon steel  
Products: \* Belzona® 1591 ,

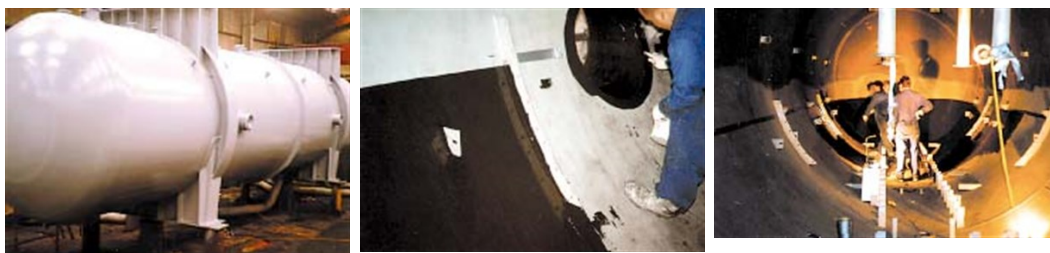
## Photograph Descriptions

Corrosion was anticipated in the lower 1/3rd of the vessel. Design Temperatures were up to 150oC with sea water present.

- \* The Coalescer vessel. ,
- \* Application underway inside. ,
- \* The lower 1/3rd was protected. ,

Application was carried out in accordance with Belzona Know-How Leaflet TCC-5.

Belzona was chosen for vessel protection following extensive testing simulating the operating conditions expected. No other coating was available to withstand the operating temperatures and pressures. Metal cladding could not be carried out within the time constraints of this fast track project.
