BELZONA HEATING PIPE FITTINGS ABOARD SUPERTANKER

Customer Location: *A 600-foot supertanker barge at Tampa Bay, Florida, U.S.A.*

Application: *VPF-Valves, Pipes and Fittings*

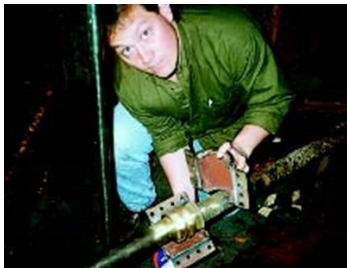
- * Following surface preparation, a collar was used ,
- * Application of product ,
- * Pipe fittings and sea dogs are happy with the repair ,

Application was carried out in accordance with Belzona Know-How Leaflet VPF-11a.
