LONG TERM ROOF REPAIR BY BELZONA

ID: 1904

Customer Location: *Old private villa, Italy*

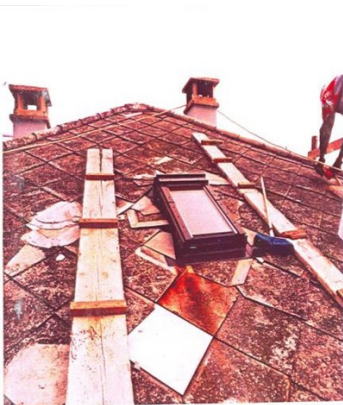
Severely deteriorated asbestos roof tiles were no longer providing weather protection.

- * Damaged roof in 1985 ,
- * Roof application after 10 years in service ,
- * Close-up after 10 years in service ,
- * Refurbishment in 2008 again with Belzona® 3111 ,

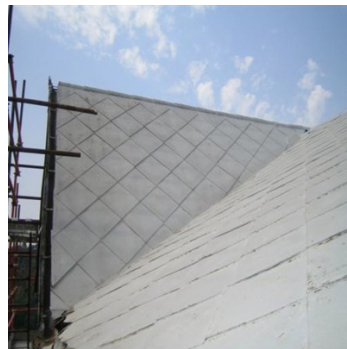
After 10 years in service, the application was reviewed and still found to be in an excellent condition. Due to the reliable performance of Belzona, the customer opted again for Belzona® 3111 to refurbish the roof after 23 years service.
