BELZONA REPAIRS AN UNDERGROUND SEWAGE PLANT

ID: 1905

Customer Location: Underground sewage plant / UK
Application Date: 2011

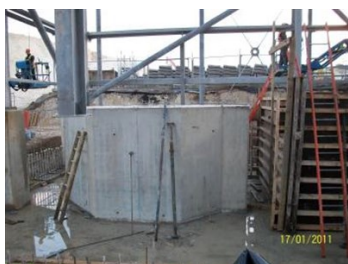
- * 1. Tank construction ,
- * 2. Before the application ,
- * 3. Application of Belzona 5811 ,
- * 4. Completed application ,

Coating of steel pannels with Belzona 5811 and bonding of these pannels in place onto the fresh concrete. Then, after the tank would be in place and the concrete had sufficiently cured, the panel edges and seams would be stripe coated, fully encapsulating the concrete.
