BELZONA COMPLETES FULL REFURBISHMENT OF CHIMNEY STACK

ID: 1910

Customer Location: Local council, UK

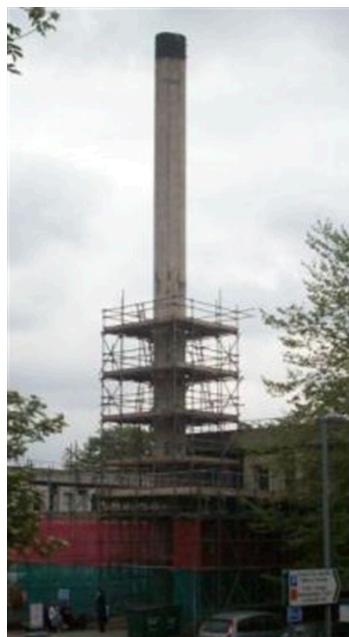
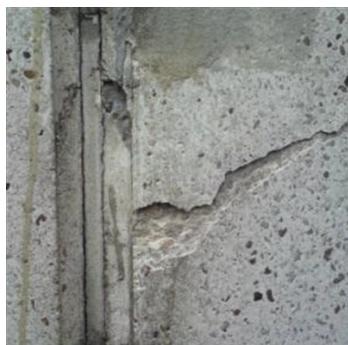
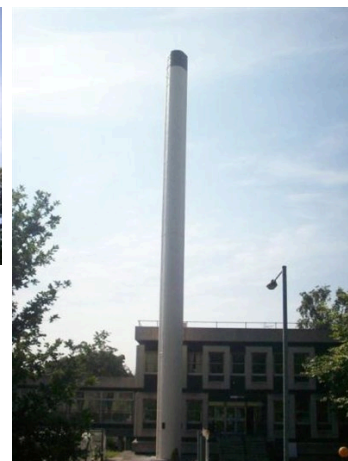
Photograph Descriptions

The chimney stack had several areas of spalled concrete due to moisture ingress.

* The chimney stack being scaffolded for access Some of the cracks requiring repair Close view of the chimney after the application General view of the completed application ,

Application was carried out in accordance with Belzona Know-How System Leaflets WPA-1 & 4. The areas of damaged concrete were repaired with Belzona® 4141 before the chimney stack was fully coated with Belzona® 5151.

Belzona products used provide the long term repair and protection required. In particular the Belzona® 4141 was ideally suited to repairing the damaged concrete on the vertical surfaces whilst Belzona® 5151 provides micro-porous self cleaning weather protection. Finally Belzona® 5811 was used at the top to provide resistance to acidic fumes.
