BELZONA RESTORES COAL BOXES

Customer Location: A University's coal fired power plant in Western Massachusetts, U.S.A.

Application: SHM-Solids Handling Machinery

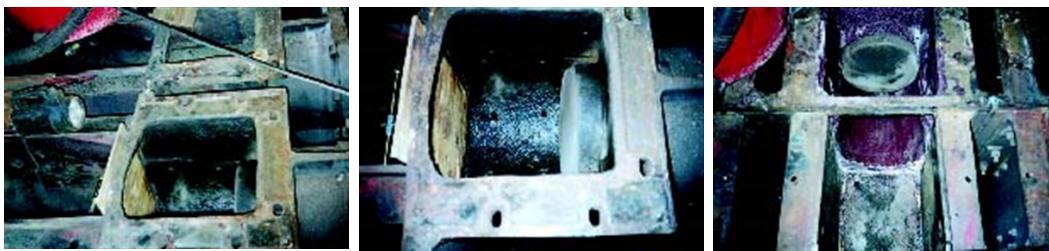
Photograph Descriptions

Coal boxes were worn from years of abrasion.

- * View of surface preparation of the six coal boxes. ,
- * Close-up of wear areas. ,
- * Completed Belzona® 1811 (Ceramic Carbide) repair. ,

The application was carried out in accordance with a modified version of Belzona Know-How Leaflets SHM-13 and SHM-14.

The cost for replacing all six (6) coal boxes would have been \$21,000 plus additional installation costs. The Belzona repairs were carried out for approximately \$2,500. A one year inspection shows no signs of wear.
