BELZONA REPAIRS 30 YEAR OLD VALVES

Application: VPF-Valves, Pipes and Fittings

Substrate: Cast Steel

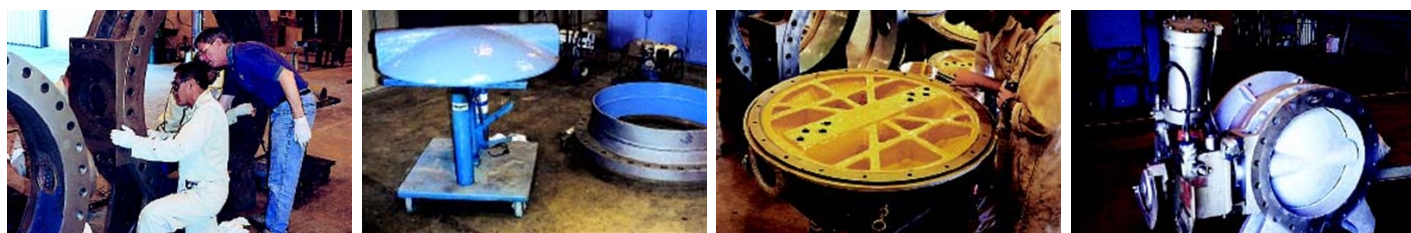
Photograph Descriptions

After 30 years of use, valves demonstrated severe damage from erosion-corrosion.

- * Valves being inspected. ,
- * Internal surfaces being protected with Belzona® 1341 (Supermetalgilde). ,
- * External surfaces are coated with Belzona® 5811 (Immersion Grade). ,
- * Completed valve, assembled and ready for service. ,

Application was carried out in accordance with Belzona Know-How Leaflets VPF-1 and VPF-2.
