# BELZONA REPAIRS BEARING HOUSING

**Customer Location:** Cement manufacturer in Pennsylvania, U.S.A.

Cement kiln-trunion bearing housing

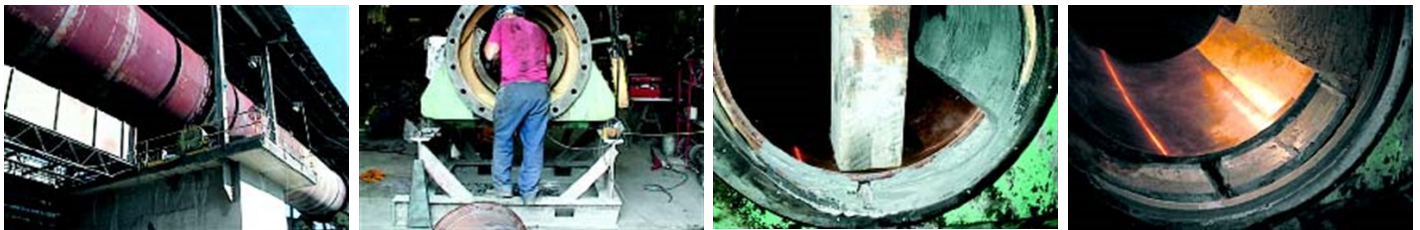
## Photograph Descriptions

Lubrication system failed and caused severe damage to bearing housing.

- \* Cement kiln ,
- \* Surface preparation of housing with new bushing to be used as former in foreground ,
- \* Bushing in place with Belzona® 1111 (Super Metal) ,
- \* Reformed bearing housing ,

Application was carried out in accordance with a modified version of Belzona Know-How System Leaflet MPT-2.
