BELZONA REPAIRS BEARING HOUSING

ID: 195

Cement kiln-trunion bearing housing

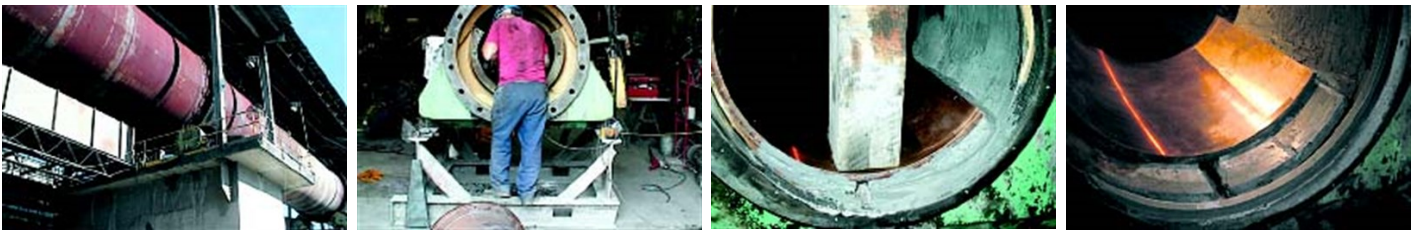
Photograph Descriptions

Lubrication system failed and caused severe damage to bearing housing.

- * Cement kiln ,
- * Surface preparation of housing with new bushing to be used as former in foreground ,
- * Bushing in place with Belzona® 1111 (Super Metal) ,
- * Reformed bearing housing ,

Application was carried out in accordance with a modified version of Belzona Know-How System Leaflet MPT-2.
