BELZONA STOPS METHANE LEAK

Industry: Water / Wastewater
Application: TCC-Tanks and Chemical Containment Areas
Substrate: Concrete
Products: * Belzona® 4111 (Magma-Quartz) ,
* Belzona® 5811 (Immersion Grade) ,

Customer Location: Sewer plant in Alabama, U.S.A.
Application Date: 1997

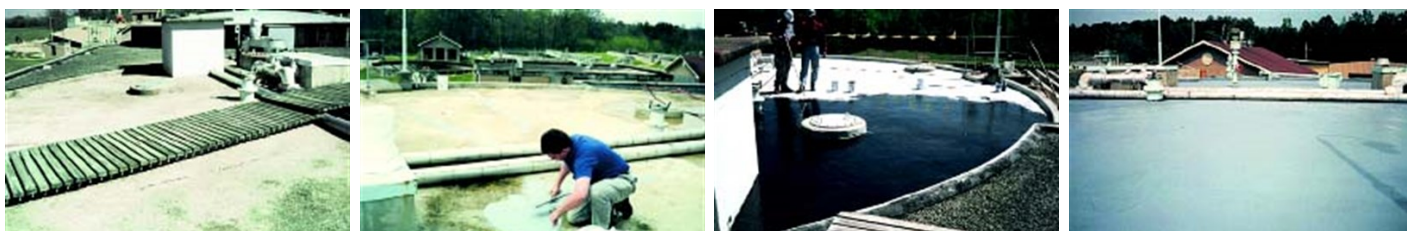
Photograph Descriptions

The 30-year-old tank had cracks and pin holes allowing methane gas to escape.

- * Top of tank with cracks and pin holes ,
- * After cleaning tank, Belzona® 4111 was used to fill cracks ,
- * First coat of Belzona® 5811 was applied ,
- * Belzona® 5811 (black and beige) were mixed to a grey color and applied for the second coat ,

Application was carried out in accordance with Belzona Know-How System Leaflets TCC-15 & FPA-1.
