# BELZONA STOPS METHANE LEAK

**Industry:** Water / Wastewater  
**Application:** TCC-Tanks and Chemical Containment Areas  
**Substrate:** Concrete  
**Products:** \* Belzona® 4111 (Magma-Quartz),  
\* Belzona® 5811 (Immersion Grade),

**Customer Location:** Sewer plant in Alabama, U.S.A.  
**Application Date:** 1997

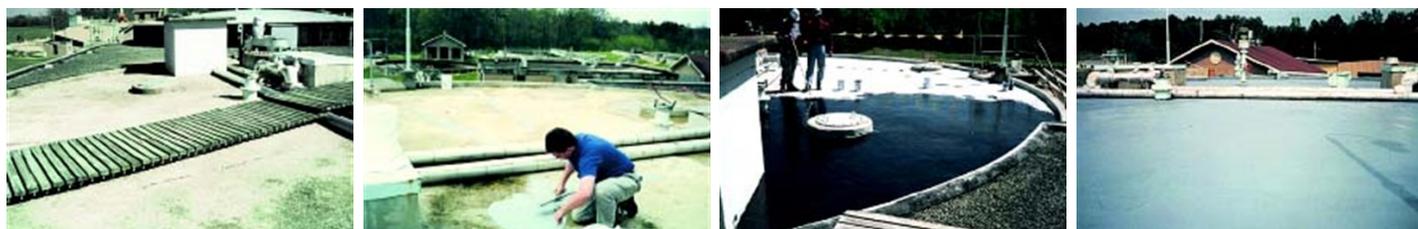
The 30-year-old tank had cracks and pin holes allowing methane gas to escape.

- \* Top of tank with cracks and pin holes ,
- \* After cleaning tank, Belzona® 4111 was used to fill cracks ,
- \* First coat of Belzona® 5811 was applied ,
- \* Belzona® 5811 (black and beige) were mixed to a grey color and applied for the second coat ,

Application was carried out in accordance with Belzona Know-How System Leaflets TCC-15 & FPA-1.
