BELZONA® SUPERWRAP PIPE REPAIR

ID: 1982

Customer Location: Major oil producer, North Sea, Norway
Application Date: April 2009

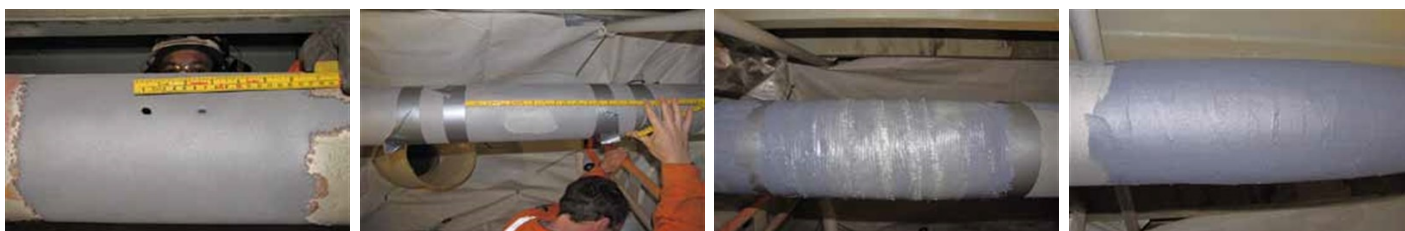
Photograph Descriptions

There were two 10mm holes through wall defects in the pipe caused by local bacterial corrosion. Prior to the application, the defects were sealed with a patch of Belzona® 1211 to provide a temporary leak sealing repair. The client needed the pipe system back in service as soon as possible.

- * Defective pipe prior to repair ,
- * Grit blasting and preparing the application area ,
- * Second spiral applied ,
- * Finished application ,

A Belzona® SuperWrap repair, compliant to ISO/TS 24817 and ASME PCC-2 Article 4.1, was applied to provide reinforced protection to the weak and vulnerable areas of the corroded pipework. Using a Belzona® SuperWrap repair, the client was able to eliminate the need for hot work and this approach also minimized the time the pipe system was out of service. The pipe repair was completed within two hours and was back to full strength following a forty-eight-hour cure period.
