BELZONA SEALS SWIMMING POOL LEAKS

ID: 205

Expansion joints in swimming pool

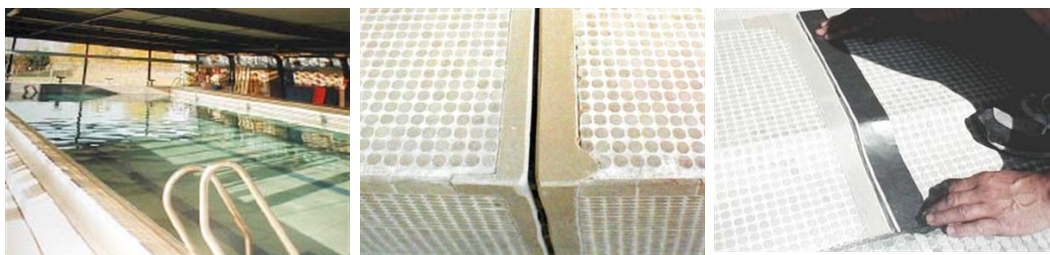
Photograph Descriptions

The original Silicone sealant had deteriorated allowing large water losses.

- * General view of the pool ,
- * Joint nosings rebuilt with tinted belzona® 4111 ,
- * Joint being masked prior to sealing with Belzona® 2211 ,

Application was carried out in accordance with Belzona Know-How System Leaflet FPA-6.

Water losses were estimated to cost \$3,300 per month (replacement, heating and treatment). This type of application has been carried out for 14 years with great success. The Belzona® 4111 is tinted blue, grey and beige to match the pool design.
